# **FRUITLAND MAGNESIUM FIRE INCIDENT**

**INCIDENT # CA-LAC-170501**

## **FIRE IMPACT INSPECTION REPORT JUNE 23, 2016**

**Prepared by LACoFD  
Health Hazardous Materials Division  
Damage Inspection Team**

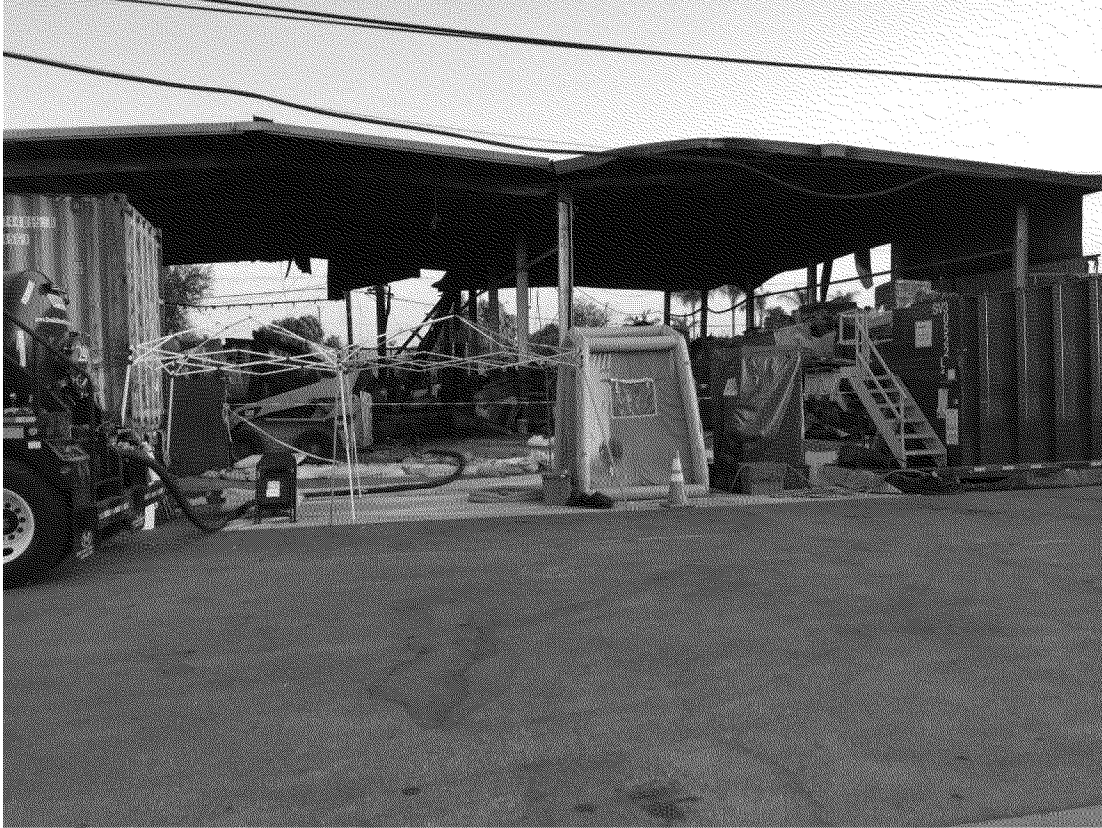
Extent of Damage: ☐ Minor ☐ Moderate ☐ Major ☒ Destroyed

Comments: Two buildings and a large overhead structure destroyed.

**PHOTO #1 – Front view of 3570 Fruitland Avenue.**

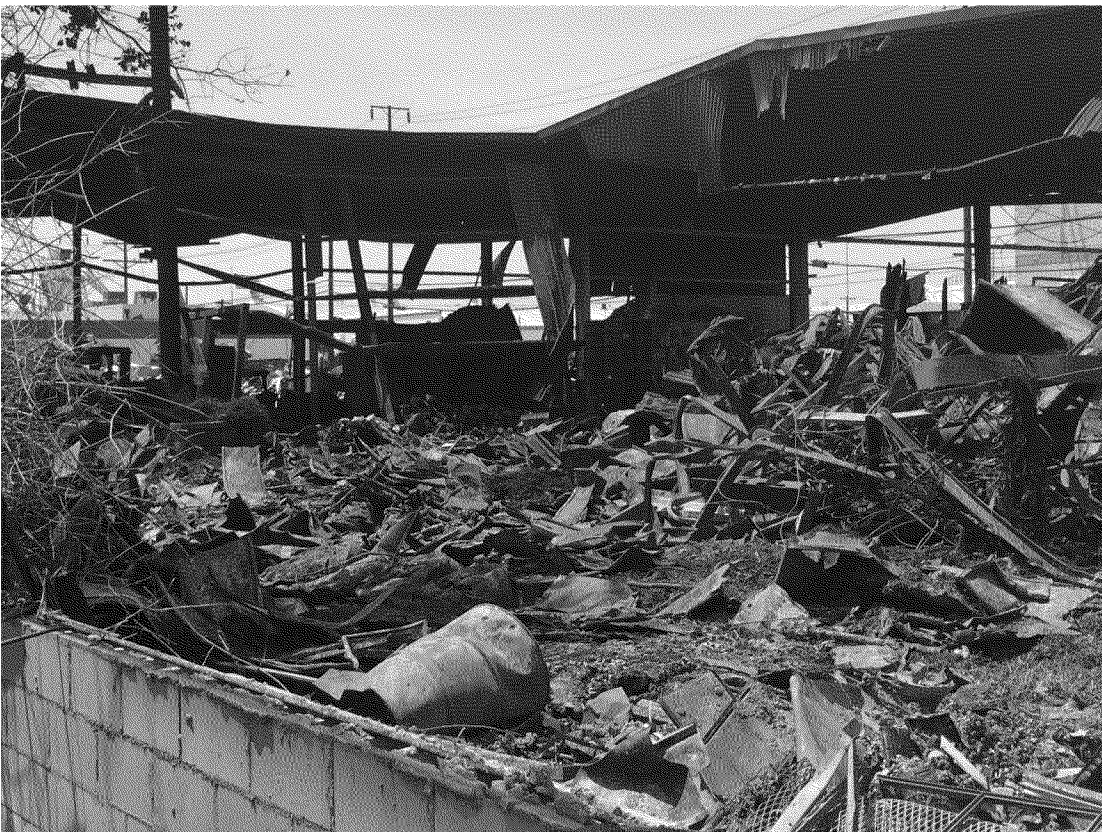
**PHOTO #2 – Rear view of 3570 Fruitland Avenue.**
